LOW CYCLE COMPRESSIVE FATIGUE
FAILURE OF E GLASS-EPOXY COMPOSITES

Gerald Sedor
Rodney K. Watterson

MASSACHUSETTS INSTITUTE OF TECHNOLOGY
AEROELASTIC AND STRUCTURES RESEARCH LABORATORY

March 1972

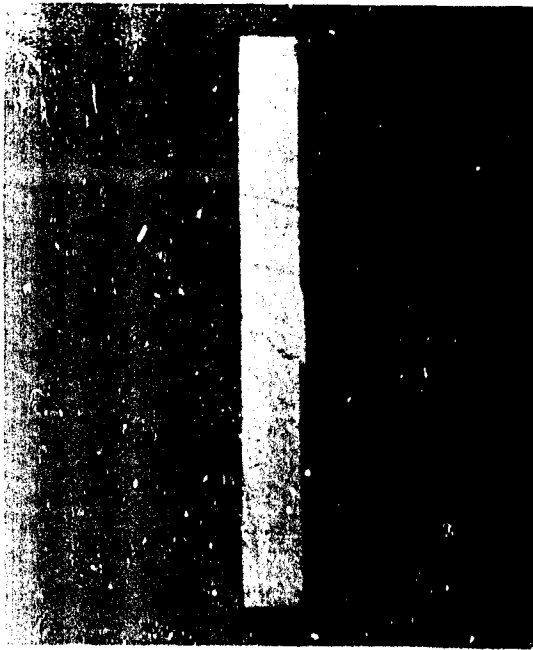
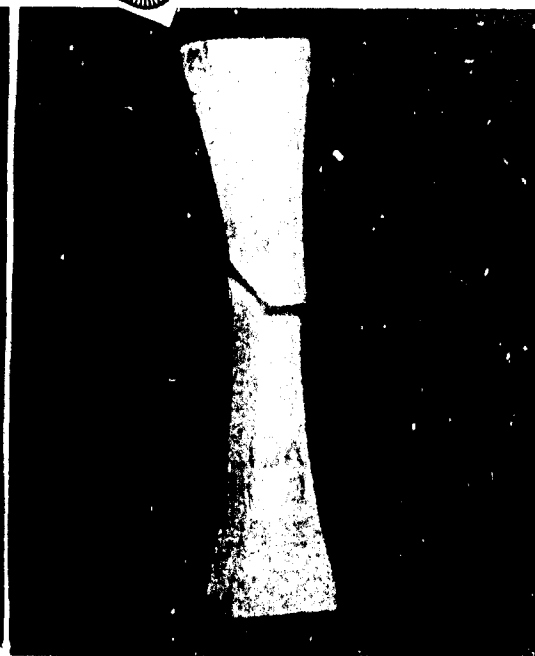
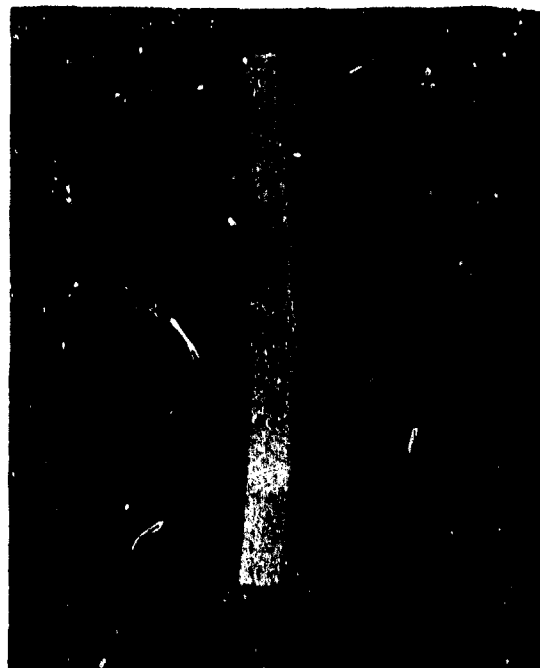
Figure 3

On a macroscopic level, failures under compressive static or fatigue loading tended to occur in a shear mode when the specimens were restrained from buckling by using the support jig. The shear line generally occurred near, but not precisely centered on the section of minimum area. Three basic variations in shear failure were observed:

- (1) A slant fracture along a single fracture plane inclined approximately 45 degrees to the load axis.
- (2) A double slant fracture, or single "V", with either side of the V inclined at approximately 45 to 60 degrees to the load axis, and extending throughout the thickness of the specimen.
- (3) A double "V", usually extending through only part of the thickness.

Typical examples of the above variations in shear failure are illustrated in Figure 3. A fourth type of failure, not shown,

Typical Failures
